Mould Damage - Commercial offices

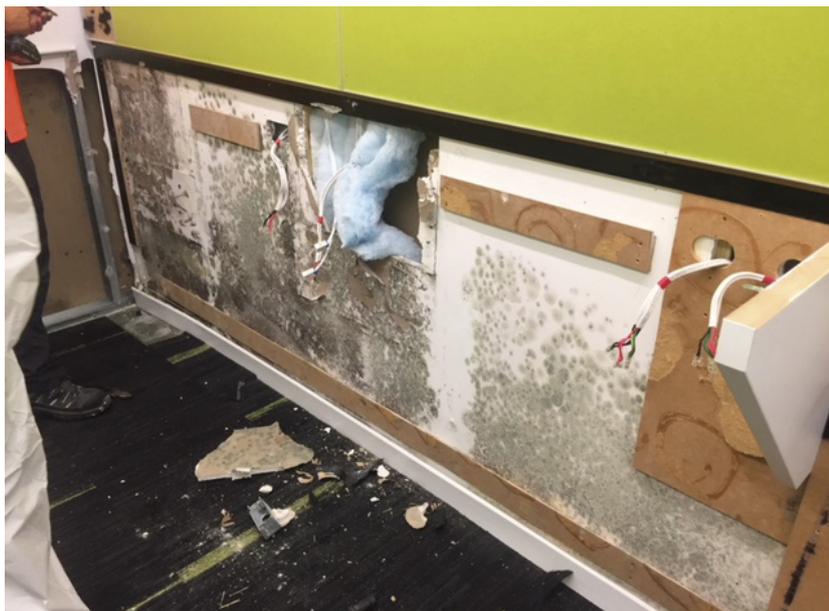
Most modern offices are equipped with ducted Heating, Ventilation and Air Conditioning (HVAC) systems to control the environment for the comfort of employees. Occasionally these HVAC systems are installed in ceiling cavities to save space and while everything is operating as expected, there's no problem. Unfortunately for one office in NSW there was a problem when the HVAC system in their ceiling cavity developed a slow water leak which wasn't noticed for a long period because the water was leaking slowly into an internal wall cavity. Eventually a staff member noticed mould growing on the plasterboard wall beneath a bench and reported the outbreak to the Facilities Manager (FM).

Understanding the urgency of the matter, the FM investigated the source of the mould, determining there was elevated moisture within the wall cavity directly below the HVAC system. The HVAC contractor was immediately informed, attending site soon after to stop the leak. With the leak repaired the FM contacted ADR for assistance with the removal of the mould. ADR Mould Remediation Operators attended site and performed the necessary risk assessment and developed a Safe Work Method Statement (SWMS) for the project.
