MOULD DAMAGE MAKE SAFE

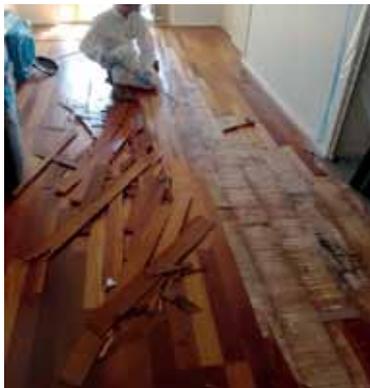
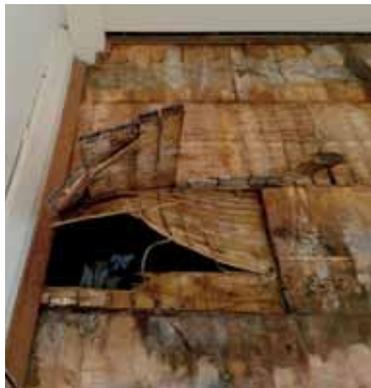
As many regular readers would know, it is extremely important to attend and mitigate water damage claims ASAP following an escape of liquid ingress. Failure to adequately dry water affected flooring in a suitable time frame will inevitably lead to a mould outbreak. ADR were recently engaged to attend one such claim where the Insured did not contact their Insurer or directly engage a qualified Restoration company to dry their apartment following a significant water ingress. Unfortunately because ADR were not engaged immediately following the water ingress Event, visible mould was present in several areas of the small apartment. The floors comprised a number of layers of floating timber veneers etc. laid onto the concrete slab, which had trapped the water, thus creating a favourable breeding ground for the fungal growth. The multiple layers of floor boards were heavily damaged and beyond Restoration, therefore were immediately removed as instructed by the Loss Adjuster presiding over the claim.

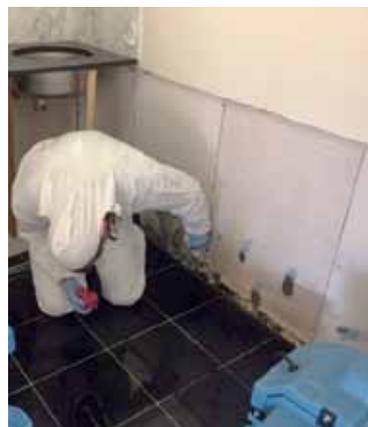
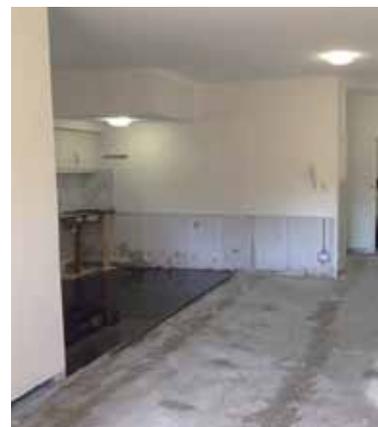
ADR's experienced staff inspected all areas of the unit and also noted high levels of moisture in some of the plasterboard walls and kitchen cabinetry, indicating water was trapped in the wall cavity. ADR sought authority to remove the wet

plasterboard (up to 500mm from the bottom only) and skirting boards in order to inspect the area for mould growth. Visible mould was found on the back of the plasterboard, cabinetry and wall frames. ADR staff removed the affected materials and carefully wrapped and bagged them to prevent cross contamination with other areas of the building as they were removed and disposed. With the affected building materials safely removed, ADR staff decontaminated the area and treated the surfaces with an antimicrobial agent before installing mechanical drying equipment. ADR returned to site every 3 days to check on the progress of drying, using moisture meters to measure the level of moisture (WME) in the concrete and wall frames until acceptable levels of moisture were achieved. ADR Operators treated the affected areas to neutralise and remove any mould that may have still been present following the removal of visibly mould affected materials. Once the treatment was complete, biological samples were collected and despatched to a qualified third party mycologist for culture, analysis and report. A report was prepared by the mycologist indicating the mould levels were within expected range for normal mould ecology, demonstrating that ADR staff had performed a successful Remediation and the apartment was deemed safe for the building contractor to begin the reconstruction works.
