# Professional Restoration Services Newsletter

NOVEMBER 2017

## Water Damage Restoration - High rise city offices

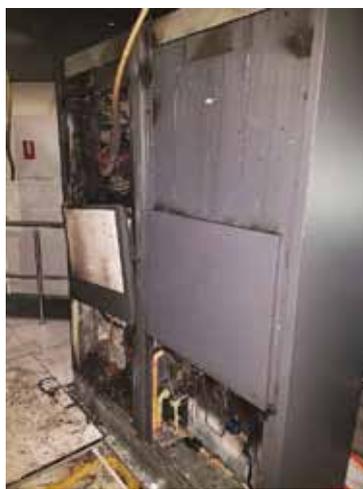
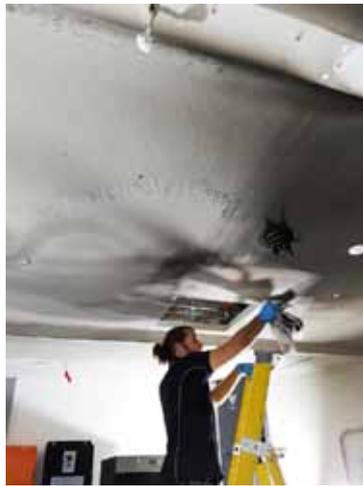
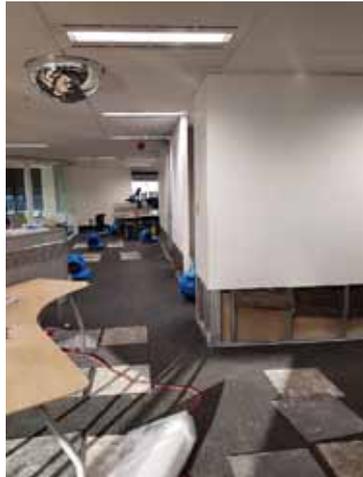
The 21st floor of a multi level building in Sydney was affected by a water ingress when one of the appliances in the services room overheated and ignited a small fire, causing fire extinguishers to automatically open to extinguish the flames. The automatic fire extinguishers deposited 1000's of litres of water into the utilities room which unfortunately inundated most of the floor of the offices. The Event occurred on a Sunday morning while the offices were unattended, however, the manager of the building was alerted to the problem by the fire safety company and quickly attended site to assess the damage. The building manager wasted no time in contacting ADR to request urgent mitigation services at the affected office. ADR's on-call staff were quick to respond to the call for assistance and immediately assembled and deployed a team of Restorers to the city building to begin the mitigation works. ADR's experienced staff performed a risk assessment and site inspection, identifying the areas that were affected. ADR commenced the mitigation process by using large extraction machinery to remove the residual water from the carpet tiles throughout the open plan offices. Temporary plastic containment walls known as Zip Walls were used to isolate different zones within the affected level to improve the efficiency of the drying equipment and reduce drying times throughout the large open office area. Dozens of air movers were strategically installed in numerous locations across the floor to create air movement in order to dry the environment. Once the drying equipment was installed and the drying process was underway, ADR's staff began to remove the thermally damaged racking and appliances that were located in the heavily affected utilities room. Carefully dismantling the various components and wrapping them in plastic prevented contamination of other offices as they were transported off site for disposal. With damaged equipment removed, the ADR Operators decontaminated the soot affected utilities room, removing all traces of soot from the walls, floors ceilings and fixtures. Drying equipment was then installed in this area to reduce moisture levels. Regular monitoring of the moisture content in the carpet and walls of the offices indicated that water was trapped in the steel C channel of a number of the internal plasterboard walls. ADR staff cut and removed the bottom 500mm of plasterboard sheeting of the affected walls to allow for the trapped water to be removed and also expose the wall cavity to allow for the drying equipment to be more effective at reducing the moisture content within the cavity. ADR staff also decontaminated the office furniture etc. that was in the affected area. After a period of approximately a week, the whole 21st floor office was clean and dry and ready for other contractors to reinstate the utilities and plasterboard walls.
