WATER INGRESS MITIGATION/RESTORATION PRIMARY SCHOOL

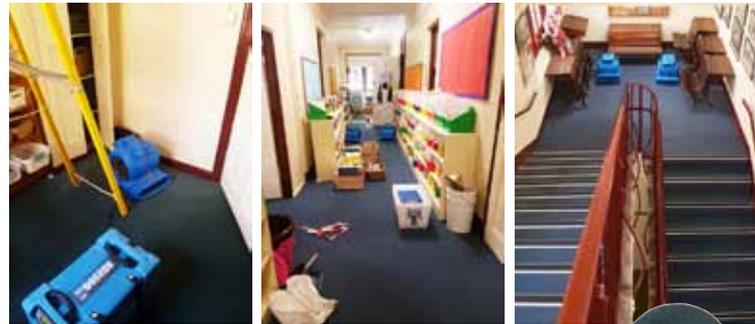
Once the extraction of water was complete the ADR Operators placed mechanical drying equipment throughout the corridors and rooms, positioned strategically to create air flow and assist in the drying of carpets and underlay.

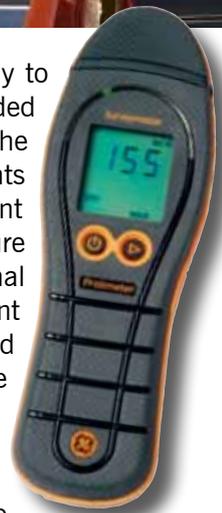
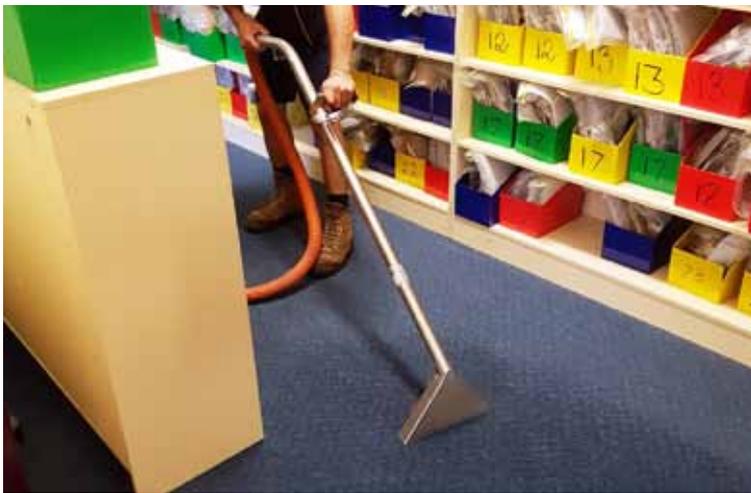
ADR staff returned to site every second day to monitor the drying process, which included creating a detailed reference map of the affected site with specific reference points for the measurements to enable consistent recording of moisture readings. Moisture levels were recorded (using a professional moisture meter), and the drying equipment was repositioned to increase efficacy and reduce drying times. Once acceptable moisture content levels were achieved in all the affected areas of the school, the drying equipment was removed. ADR staff steam cleaned the carpets and then replaced the furniture and other contents back into each room to return the rooms to a pre-Event state. Within 8 days of the Event occurring, ADR was able to Restore the rooms to a safe and usable condition, therefore allowing the students and staff to begin using the areas as normal. ADR's rapid mitigation and Restoration actions saved many days of inconvenience to the school community and saved the Insurer thousands of dollars in potential carpet and underlay replacement costs.
